Blue Flag

BF119 October 2016

It's a Swiss kind of thing

**With great respect for their vessel's history and character, Chris and Charlotte Huber spent twelve years perfecting Kinette above the waterline
 but the time had come to look below.**

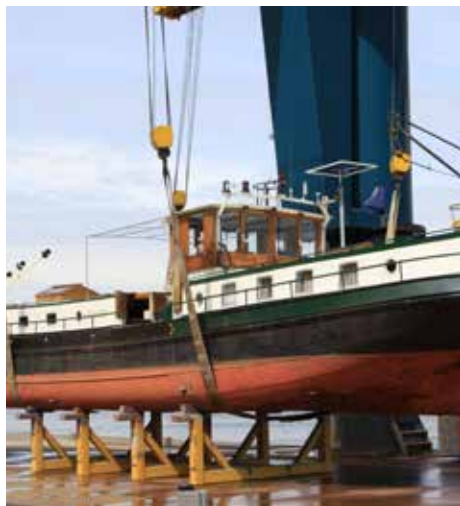
The ship is carefully placed on a heavy stand

(Friesland) in the Netherlands, where all facilities plus the expertise for sandblasting, welding and coating are close together. On a beautiful morning in May 2016 *Kinette* was hauled by Multiship's 100-ton-crane, softly placed on a heavy stand and then transported into a covered shipyard by a remote controlled hydraulic 100-ton-lift.

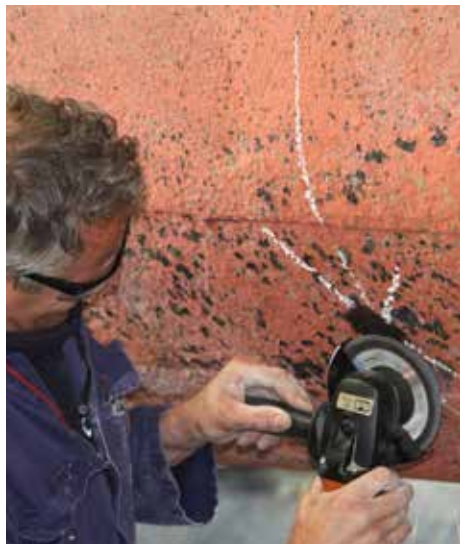
Preparation before measuring the thickness of the hull

thickness measured by an expert. With a meticulous hammer-and-ultrasound inspection the surveyor found no suspect areas, but could not totally exclude a weak spot.

His recommendation? Sandblasting. "No other method will free the hull from those old layers of tar." The rivets, we learned, should present no problem – an experienced and careful boat painter will thoroughly fill all the gaps with special material. And if we blast through a thin spot? Well, wouldn't you want to know if you had such a weakness? Nothing is easier to repair than a steel barge when it's hauled out in a shipyard!

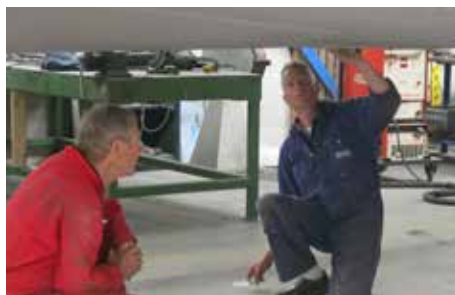
Hull inspection after sandblasting

thoroughly removed, the surveyor measured the hull as meticulously as before the sandblasting. And indeed he found a thin spot that had been masked by paint and tar. Sooner or later we would have had a leak there – according to Murphy's Law, far away from any repair facility. Now it was a simple job for the welder before the barge was rolled to the painters' workshop.

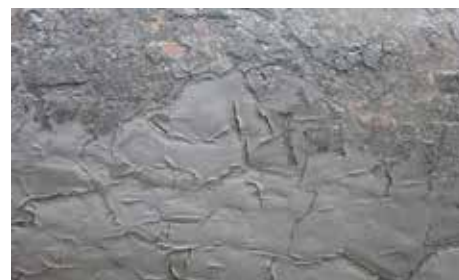
For many years Kinette's underbody was treated with tar, a common practice until tar became disapproved for environmental reasons. More recently, the hull has been treated at regular intervals with an anticorrosive primer and antifouling. But with those old, tough layers of tar underneath, this coating didn't stick to the hull as it should have. Our Swiss

Tar and rust before blasting

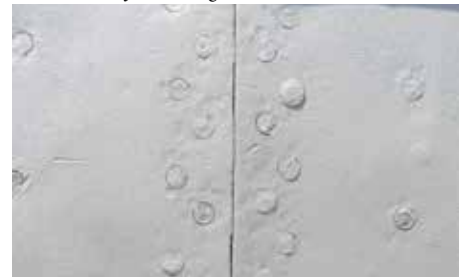
The same spot revealing bare steel after 94 years

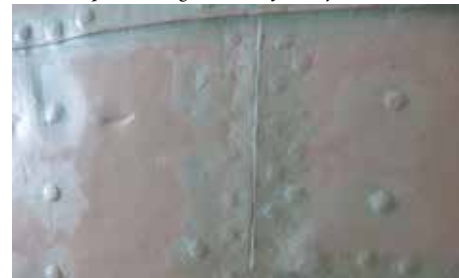
Filler has been applied

After first spraying a layer of two-component epoxy, all rivets and interstices between the riveted steel plates were covered with two-component filler. Why first one layer of epoxy and then the filler? Due to its viscosity, paint penetrates every tiny space, but does not even out all the joints and little gaps, even when sprayed. So after the first layer of epoxy, the painter

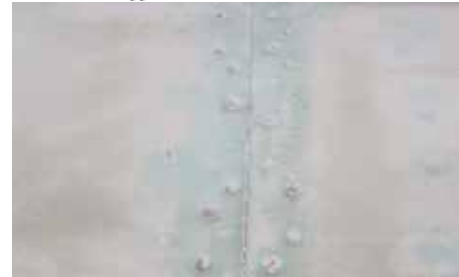
and then ground clean

After hardening, the filler was ground before the second and third layers of epoxy were sprayed. After a layer of sealer, antifouling was sprayed. The hull looked so great, we had them paint the roofs, the gunwales – everything we always painted

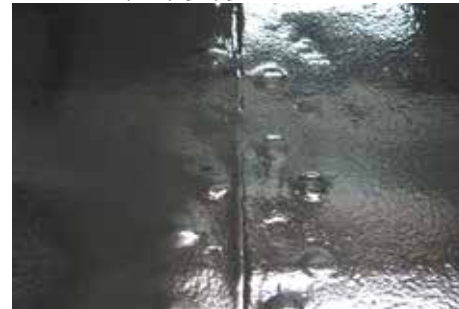
and the final topcoat, lovely!

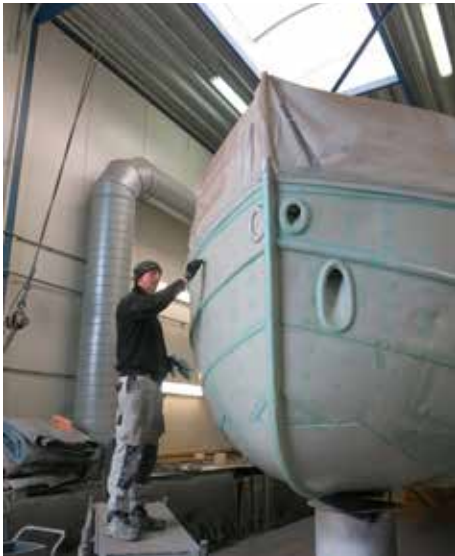
Applying the two component filler

sees exactly where he has to apply filler.

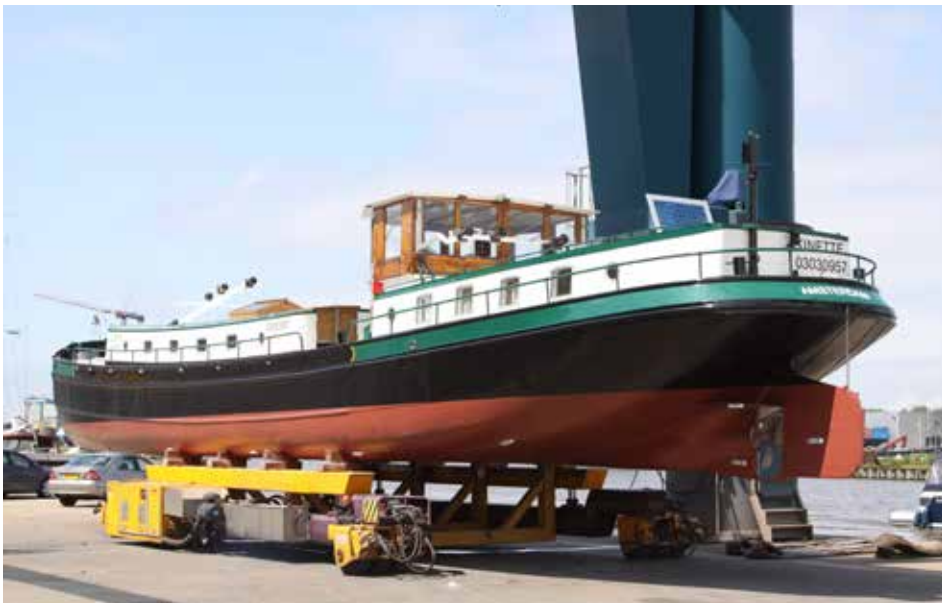
The shining results!
